UNITED STATES ENVIRONMENTAL PROTECTION AGENCY REGION 8

POLREP 1

REMOVAL SITE EVALUATION

Subject: Red and Bonita Mine Site

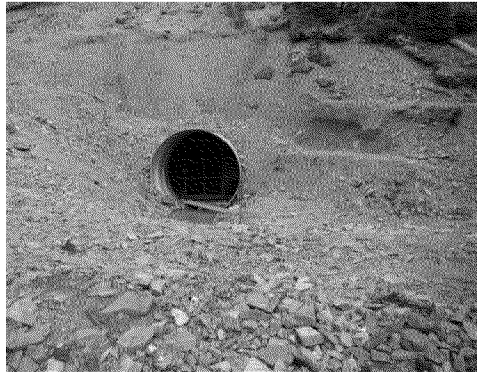
New mine portal, 2011

In 2010 EPA also initiated an investigation to determine the extent of blockage in the adit. As part of that effort, a bore hole was drilled approximately 30 feet beyond the face of the hillside slope and adit opening, and it was determined to drill into the void of the adit/tunnel. At that location a monitoring well, used to monitor the impounded water within the adit, was installed, to determine if the adit blockage was under hydraulic pressure from a possible mine pool. This was necessary to determine before the removal of the collapsed portal in 2011. It was necessary to remove the blockage to allow future entry to assess the hydrogeologic and geotechnical conditions in the adit. In addition, a future blowout of the blockage was a potential risk if the debris had not been removed. During removal of the collapsed rock debris at the portal a large volume of water was pumped (multiple times) from the adit in order to control both the pressure

against the soil/rock mass and to prevent the turbid water from releasing. All disturbed water pumped during portal excavation and later during mine entry activities received a flocculent and/or was filtered prior to release into Cement Creek. A new mine portal was installed in October 2011.

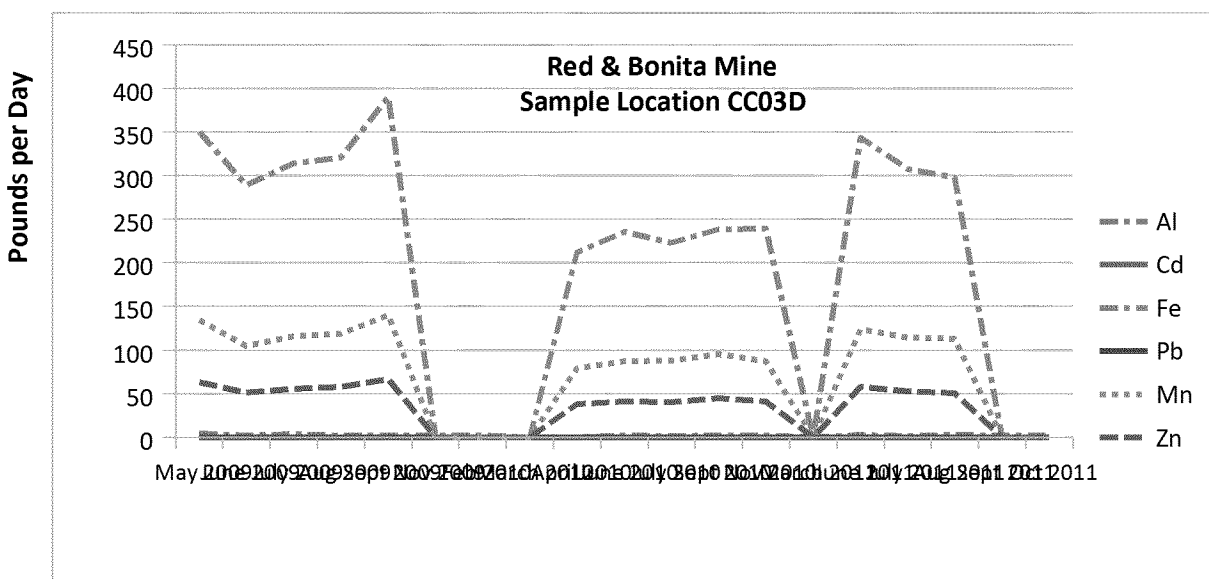
CC03D located at toe of mine dump in channelized mine discharge flow.
